Solution

The complicated design of the front axle on the Peugeot 508, 407 and Citroën C6, C5 III is susceptible to premature wear. Ball joints and knuckle bearings are affected the most often.

Strut assembly repair kit SWAG no. 62 94 4480

fits:
Peugeot 508, 407 und Citroën C6, C5 III

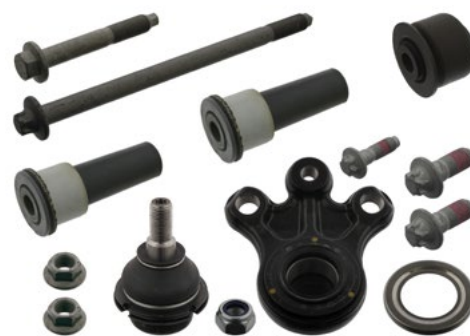
SWAG offers a unique repair solution for the aftermarket! The strut assembly repair kit contains two ball joints and knuckle bearings along with all the necessary nuts and bolts. This complete kit allows for a professional repair and saves the workshop time and the customer money! All the parts required for a repair are guaranteed to be in a Kit.

In the past the whole knuckle assembly would have to be replaced in order to repair a faulty knuckle bearing, as individual bearings are not available from the manufacturer. During a repair it is advisable to replace a spare part directly, in order to avoid any additional costs.
