Service Info

Tensioner pulleys 531 0252 30 and 531 0525 30

Risk of mix-ups

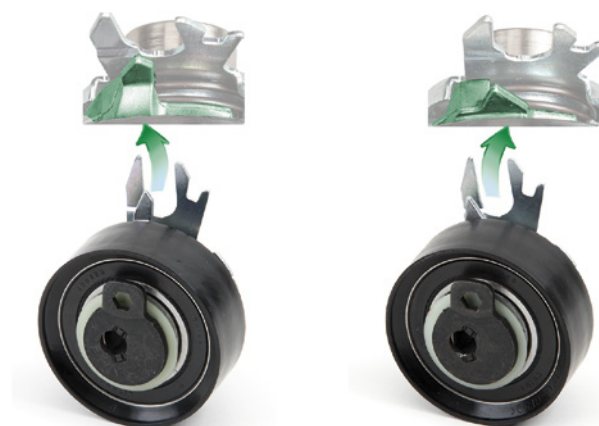
Only the indicator of the two tensioner pulleys and its arrangement are different (Fig. 1).

Fig. 1: Left - tensioner pulley 531 0252 30, right - tensioner pulley 531 0525 30

Before installation, it is extremely important to verify the part number. The similarity of the numbers increases the risk of mix-ups.

Although they look very much the same, they are technically very different. Tensioner pulley 531 0252 30 has a higher tensioning force and a larger working range than tensioner pulley 531 0525 30.

Use of the wrong tensioner pulley can cause the toothed belt to flutter and jump teeth. Engine damage may occur as a result.

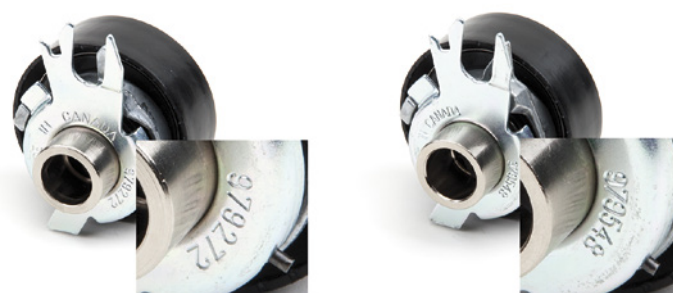
The number stamped on the back also helps to differentiate between them (Fig. 2):

article number	stamped number
532 0252 30	979272
532 0525 30	979548

Fig. 2: Left - tensioner pulley 531 0252 30, right - tensioner pulley 531 0525 30
